Cooling Tower IPSC

Concrete Repair & Protection

Reinstructa Corp.

Executive Summary

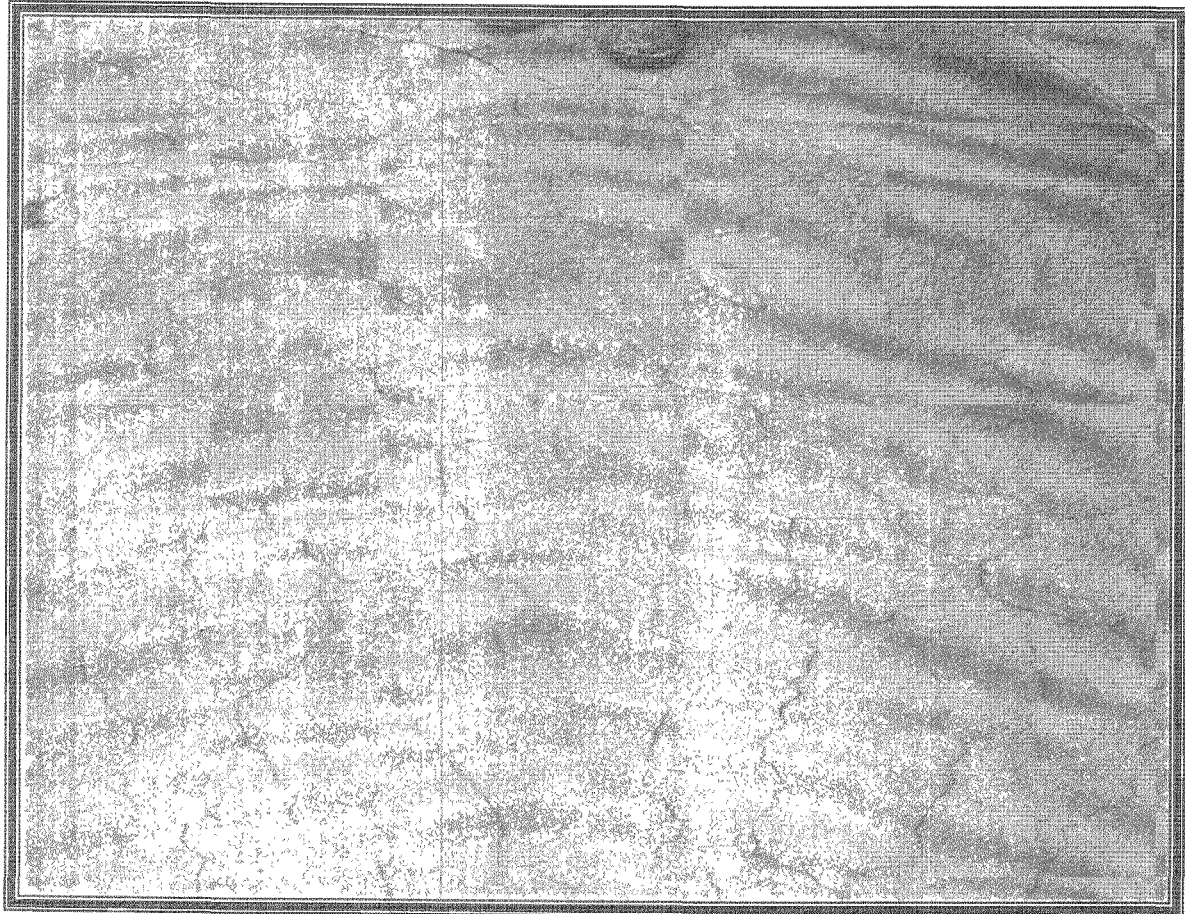
Photo #1

Roof Deck Plastic Shrinkage Cracking

Picture taken on roof of Unit 2B

1. Large quantity of plastic shrinkage cracks in concrete topping should be repaired to eliminate deterioration mechanism.

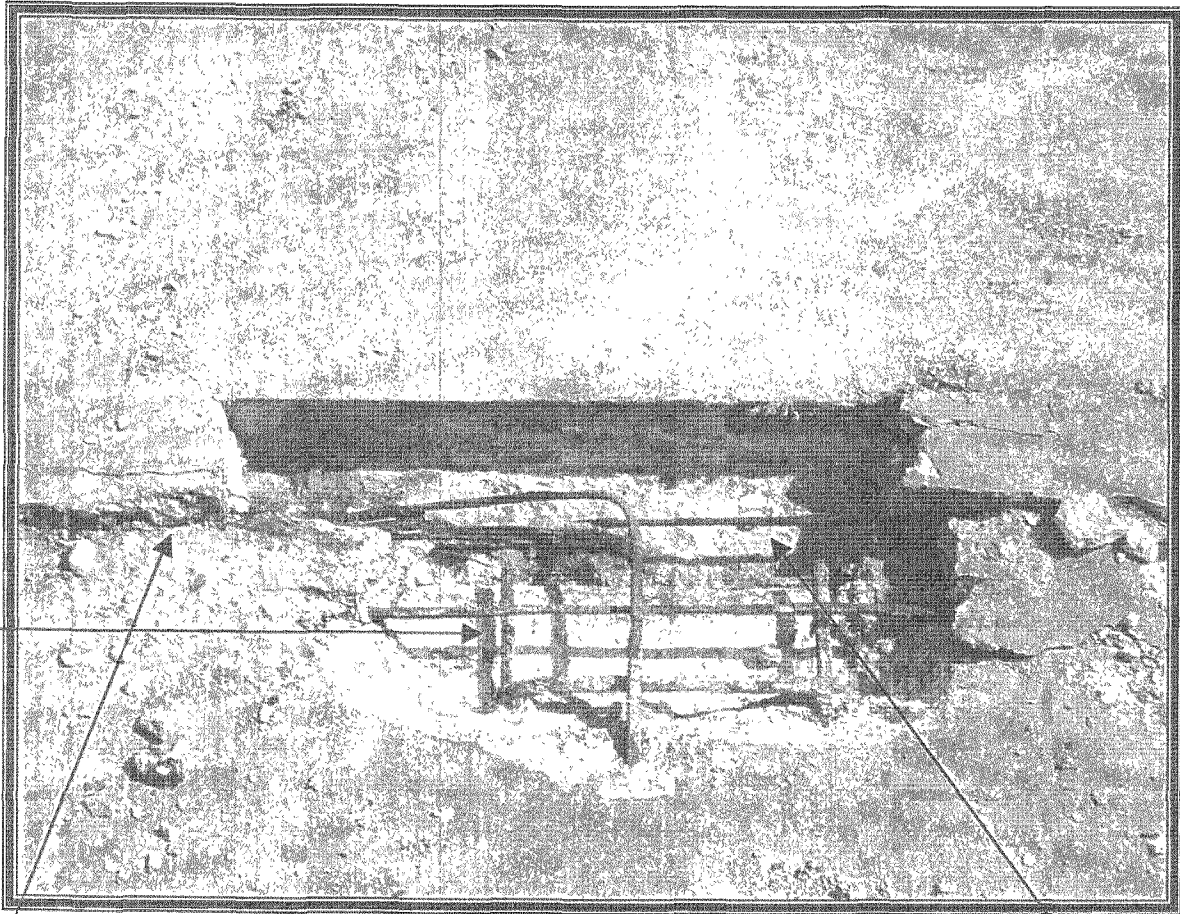
Photo #2

Inspection Location #1

Cast in place concrete topping removed to top of pre-cast roof panel at Unit 1A

1. Complete corrosion of #3 bar running parallel to crack. Corrosion of bars and strand forming connection between roof panels and topping concrete.
2. Crack in cast in place concrete topping directly above joint in pre-cast roof panel.
3. Corrosion of re-bars stops within 8-12 inches of crack location.

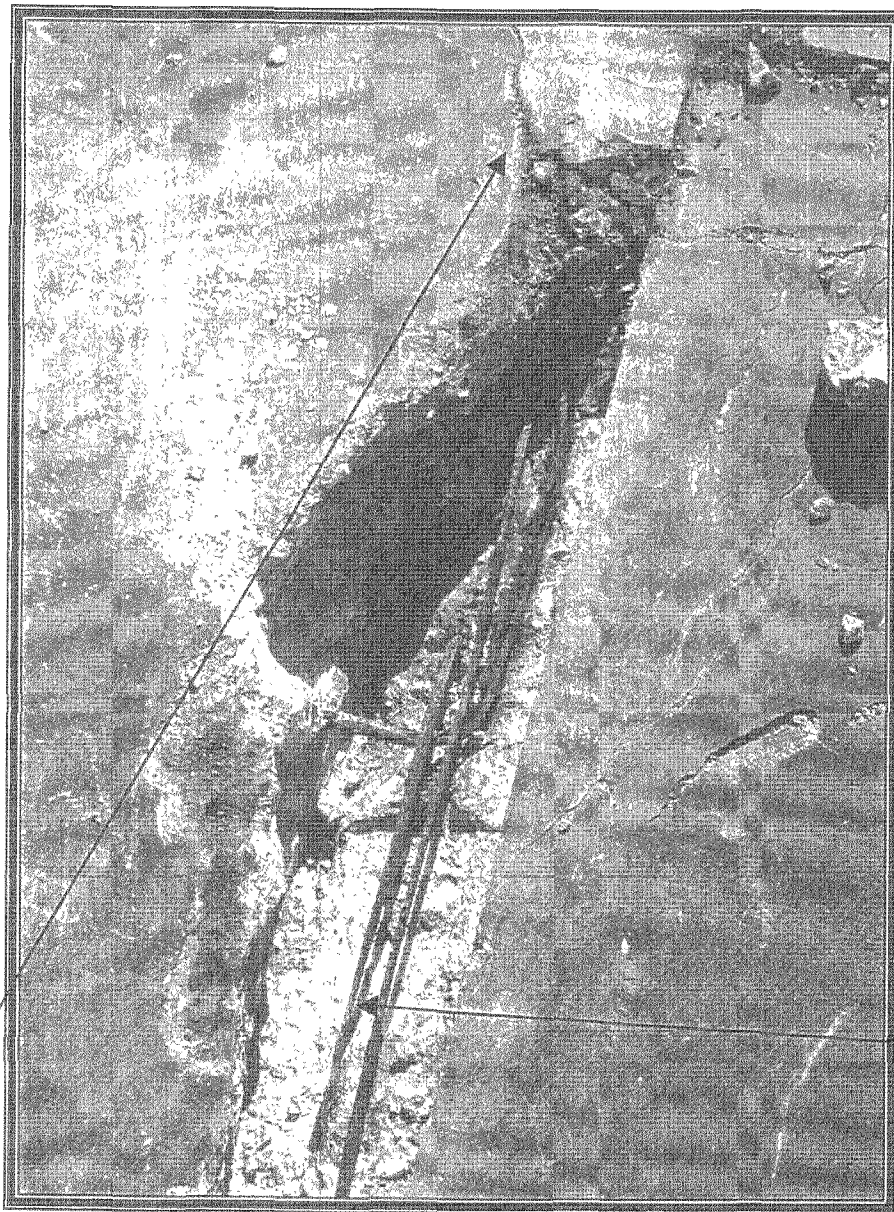
Photo #3

Inspect Location #2

Cast in place topping removed to top of pre-cast roof panel on Unit 1A

1. Crack over pre-cast roof panel joint, adjacent to but not at the sawed topping control joint.
2. Significant corrosion of re-bars forming the connection between topping and roof panels.

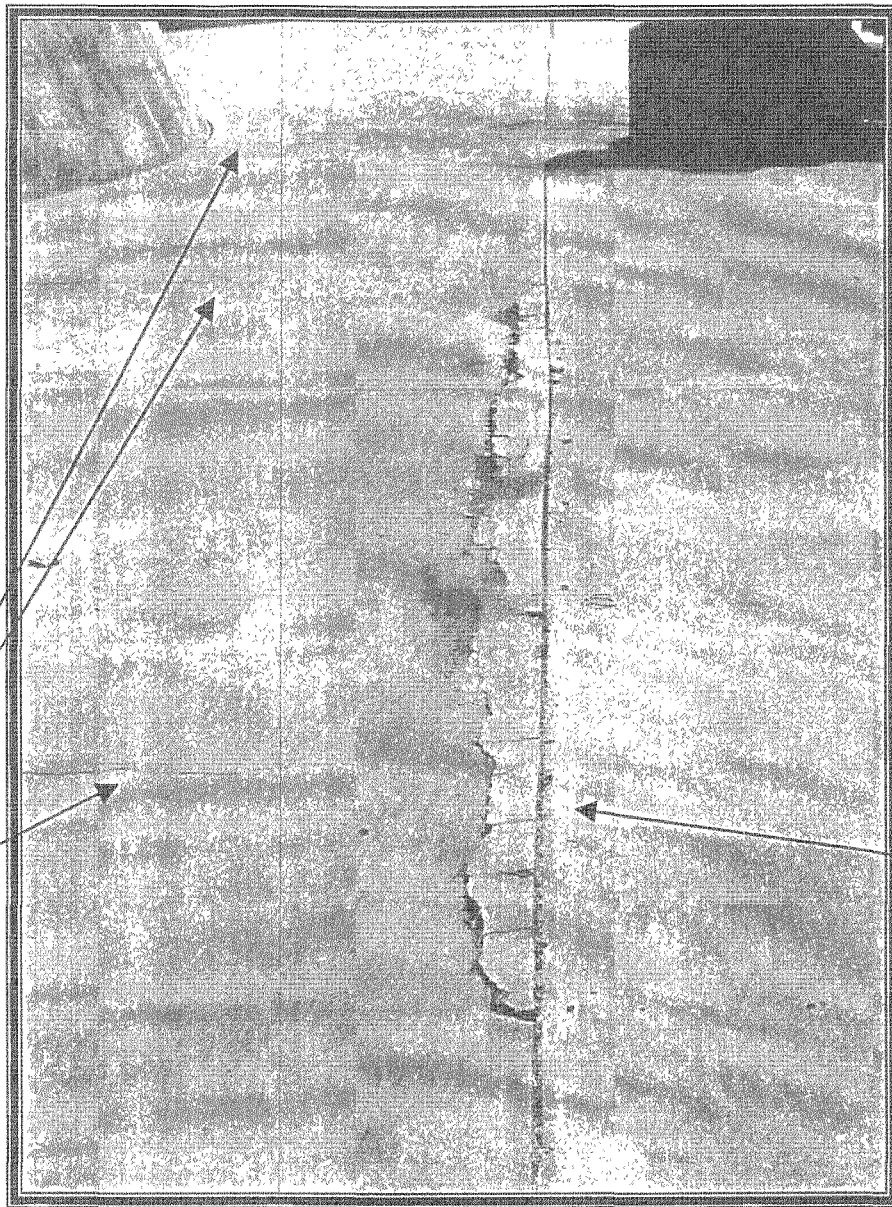
Photo #4

Cracks formed by joint at pre-cast roof panels

1. Sawed joint in concrete topping adjacent to crack. Crack directly above pre-cast panel joint.
2. Drying shrinkage cracks perpendicular to sawed joint directly above pre-cast roof panels.

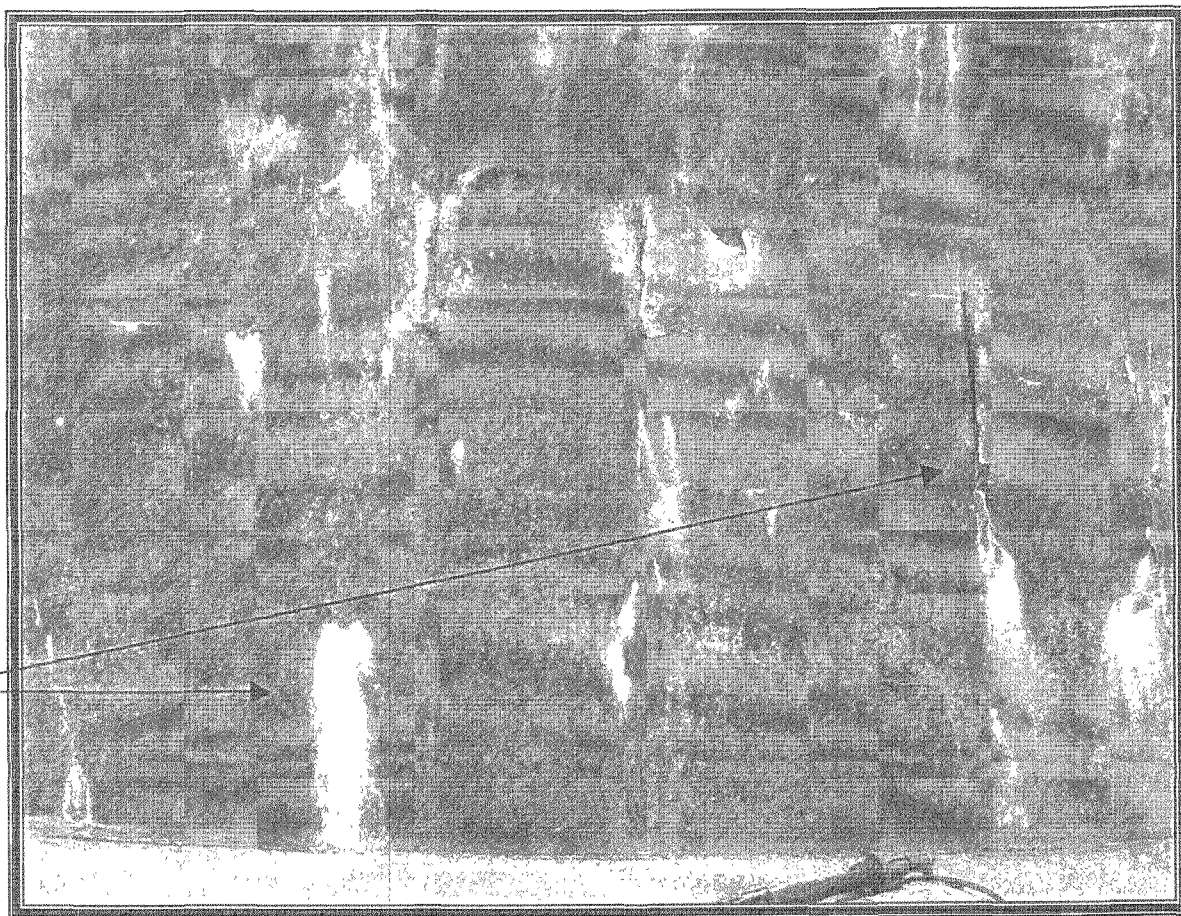
Photo #5

Free Lime leaching at Fan Stack Assembly

1. Leaching at cracks, voids and spalled concrete locations.

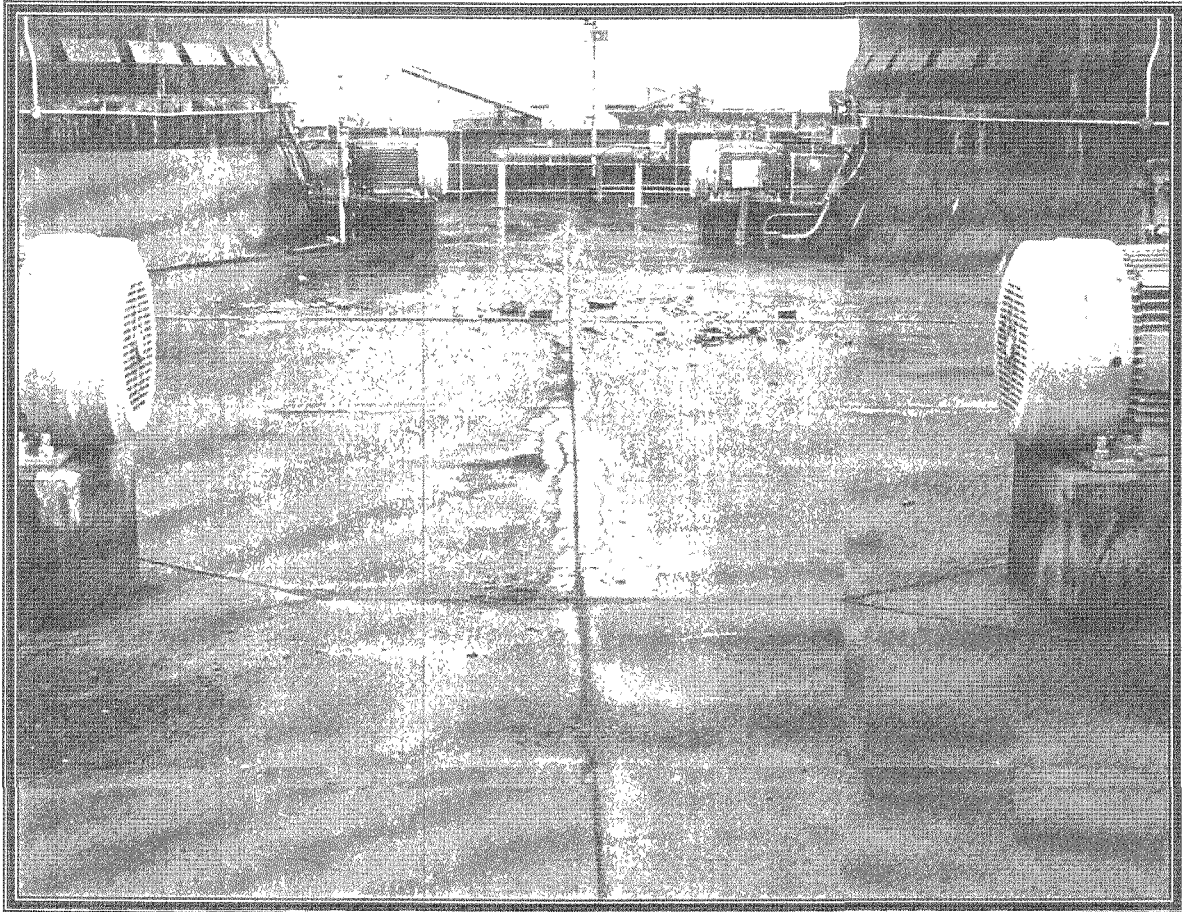
Photo #6

Wet roof deck surface from steam condensation

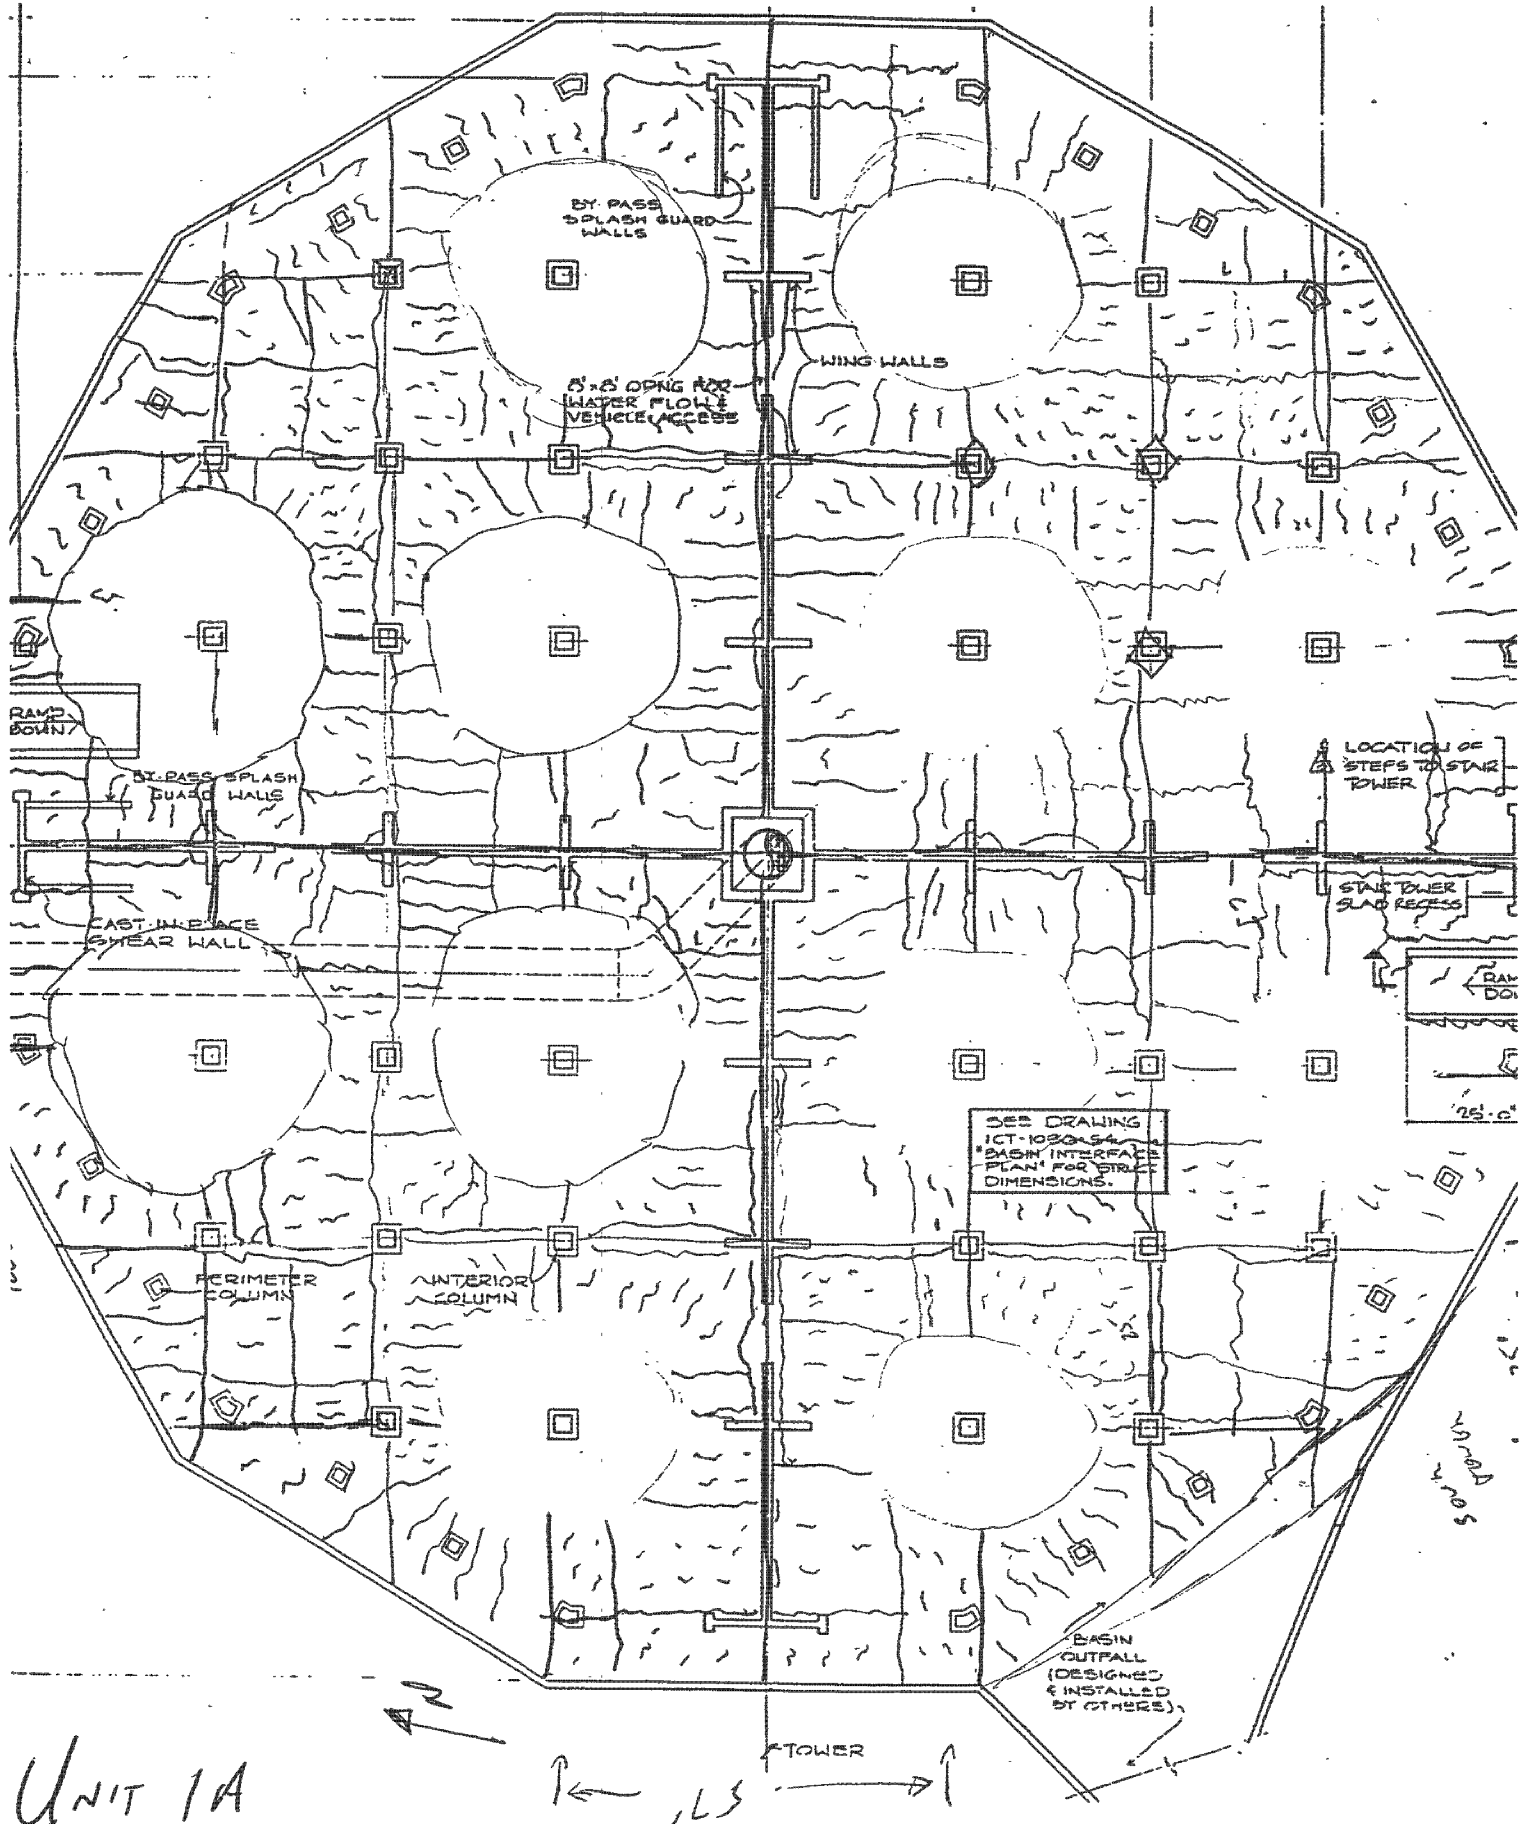
CRACK MAP

Significant cracking was observed on all unit roof decks. Two types of shrinkage cracking are present. Drying shrinkage cracking causing a "jointed" concrete topping is located at near equidistant spaces. A large number of plastic shrinkage cracks in the cast in place concrete were also observed. These plastic shrinkage cracks indicate difficult placement conditions or poor curing practice during original construction. A crack map of unit 1A was completed. (See appendix 4 for crack map). The drying shrinkage cracks are generally located over the joints of the pre-cast concrete roof panels.

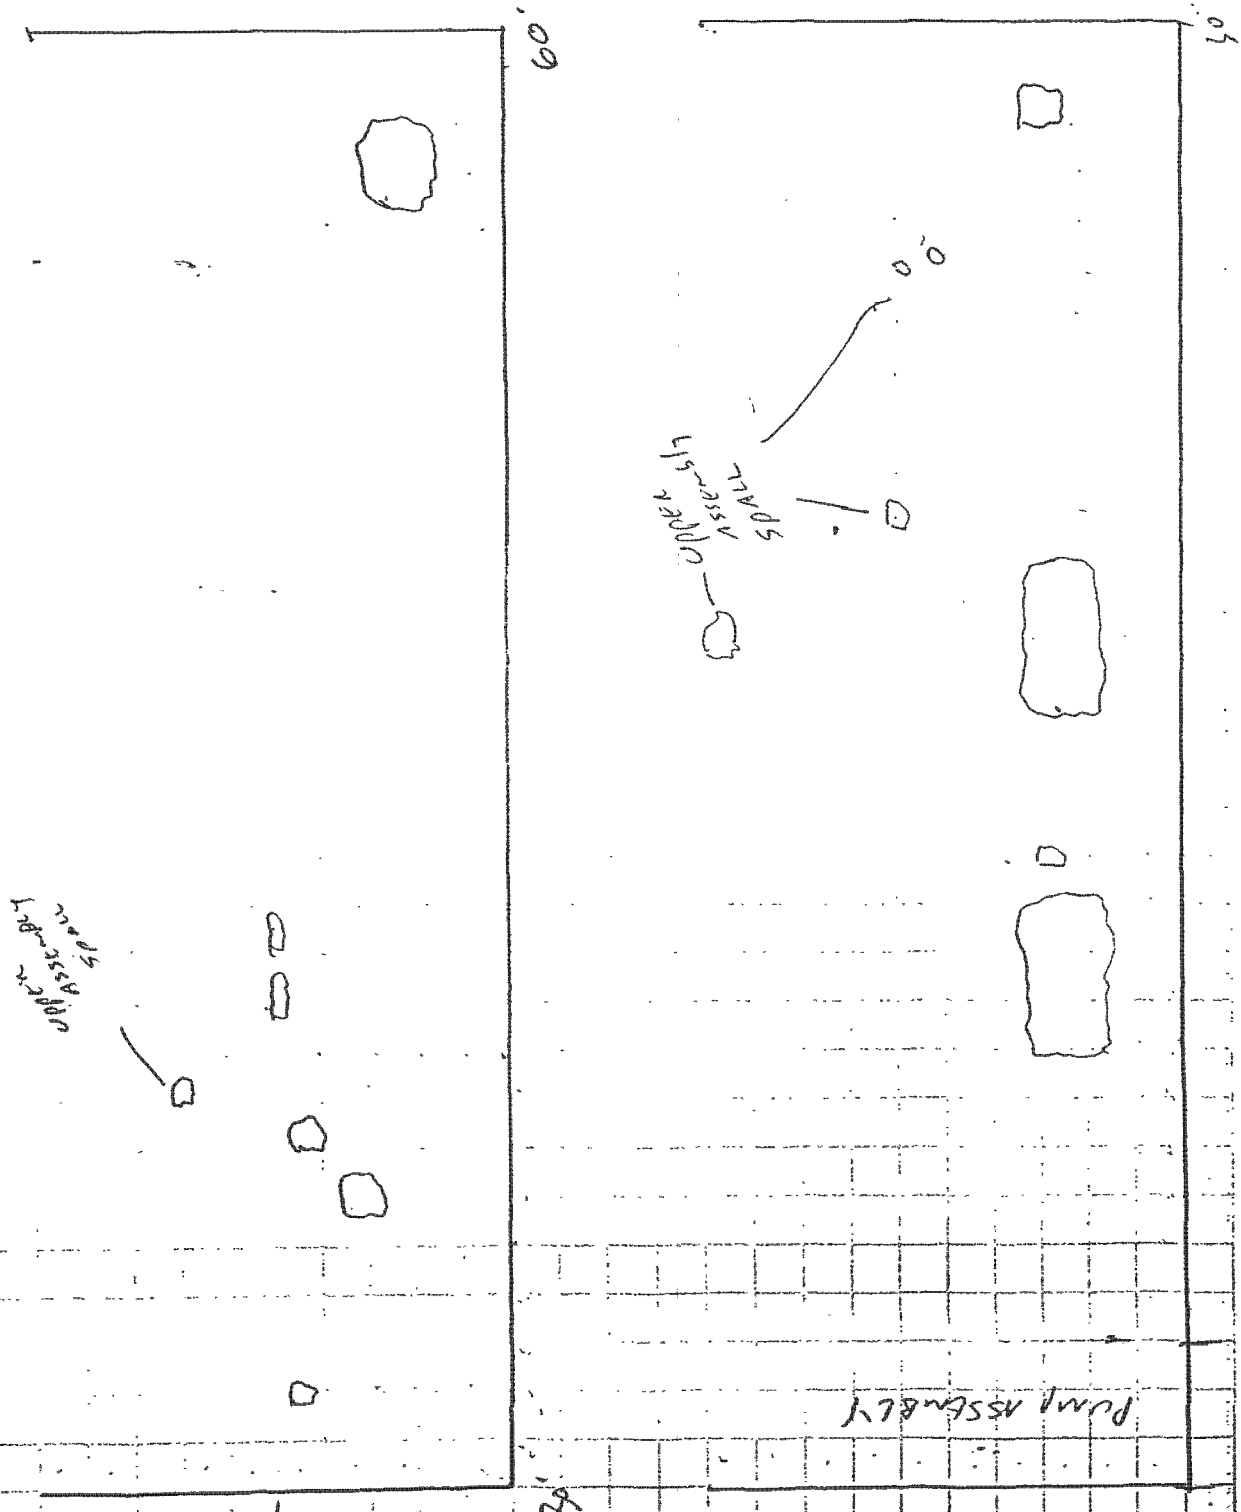
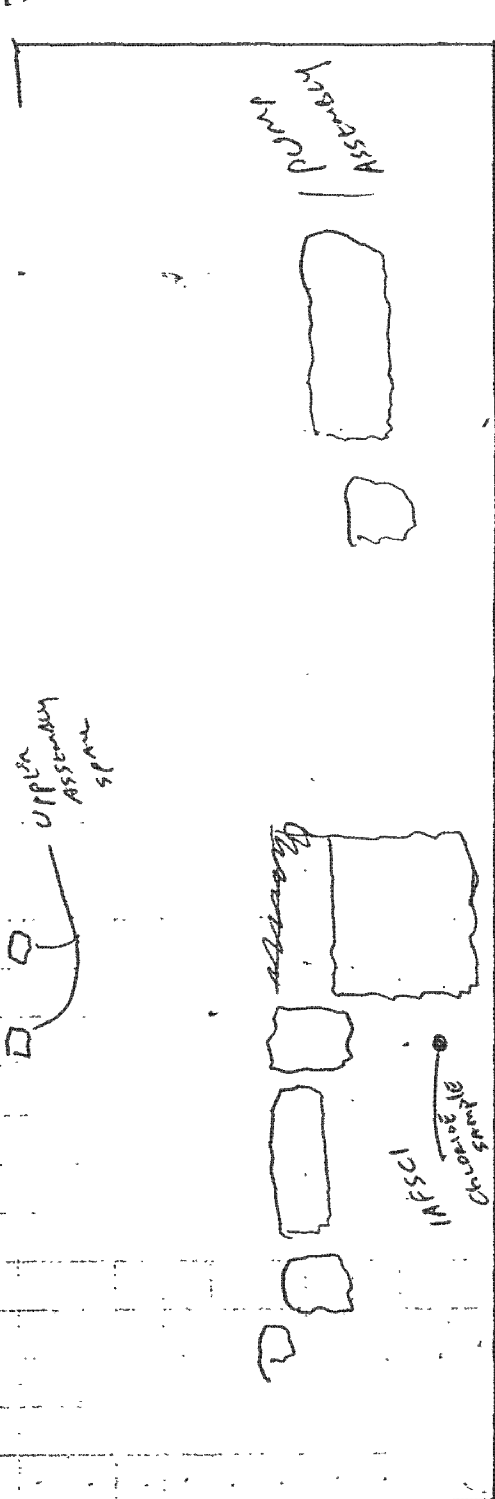
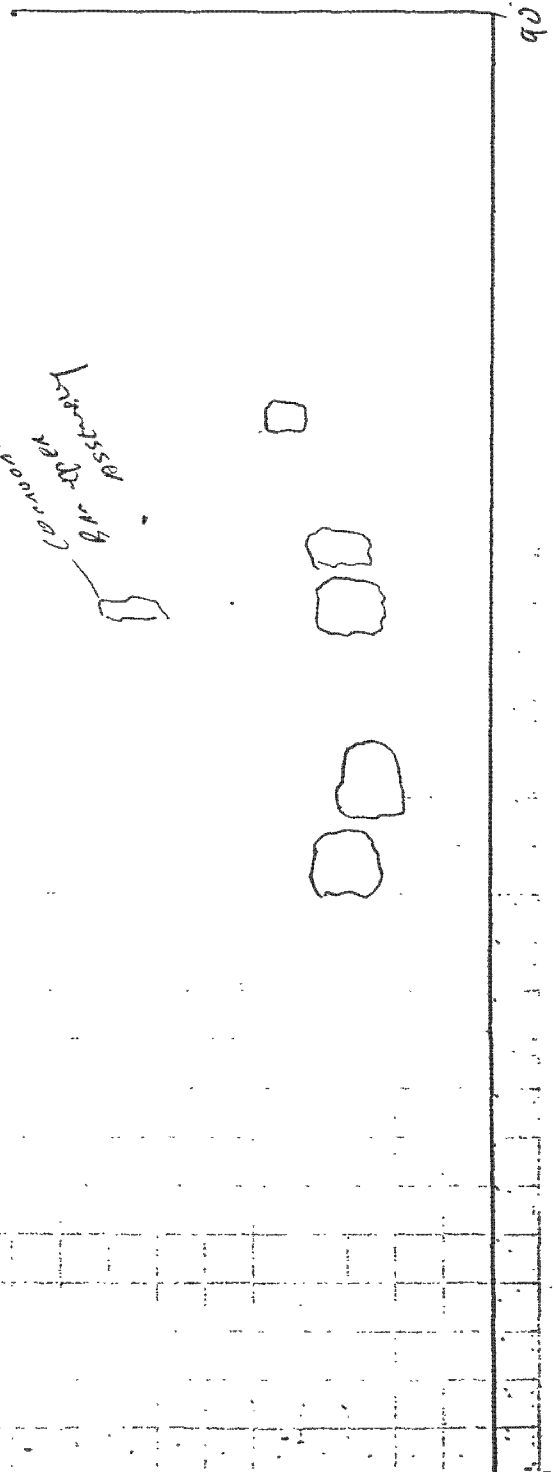
FAN STACK DELIMINATION SURVEY 1A04

Delamination mapping of fan stacks 1A04, 1A08, 2B04 and 2B07 reveal minor to modest deterioration. In the highway bridge industry, 30% concrete delamination in a bridge deck area is considered significant, requiring more than localized repair to extend its life for 20-30 additional years. The delamination and spalling in the stacks mapped, is centered almost exclusively on the lower stack assembly. Condensed cooling tower water is escaping at the cold joint between the lower and upper assembly. The area of the lower stack assembly is approximately 600 square feet. The delaminated area of the lower assembly for stacks 1A04, 1A08, 2B04, 2B07 is 10%, 5.5%, 28%, and 14% respectively. The higher delamination of 2B04 corresponds to the higher chloride content measured. We do not expect this to impose significant future deterioration. The upper assembly has
